TS-AMD-83056e
November 1984

AERIAL PHOTOGRAPHIC ANALYSIS OF WASTE STUDY SITES

Montana

AERIAL PHOTOGRAPHIC ANALYSIS
WASTE STUDY SITES

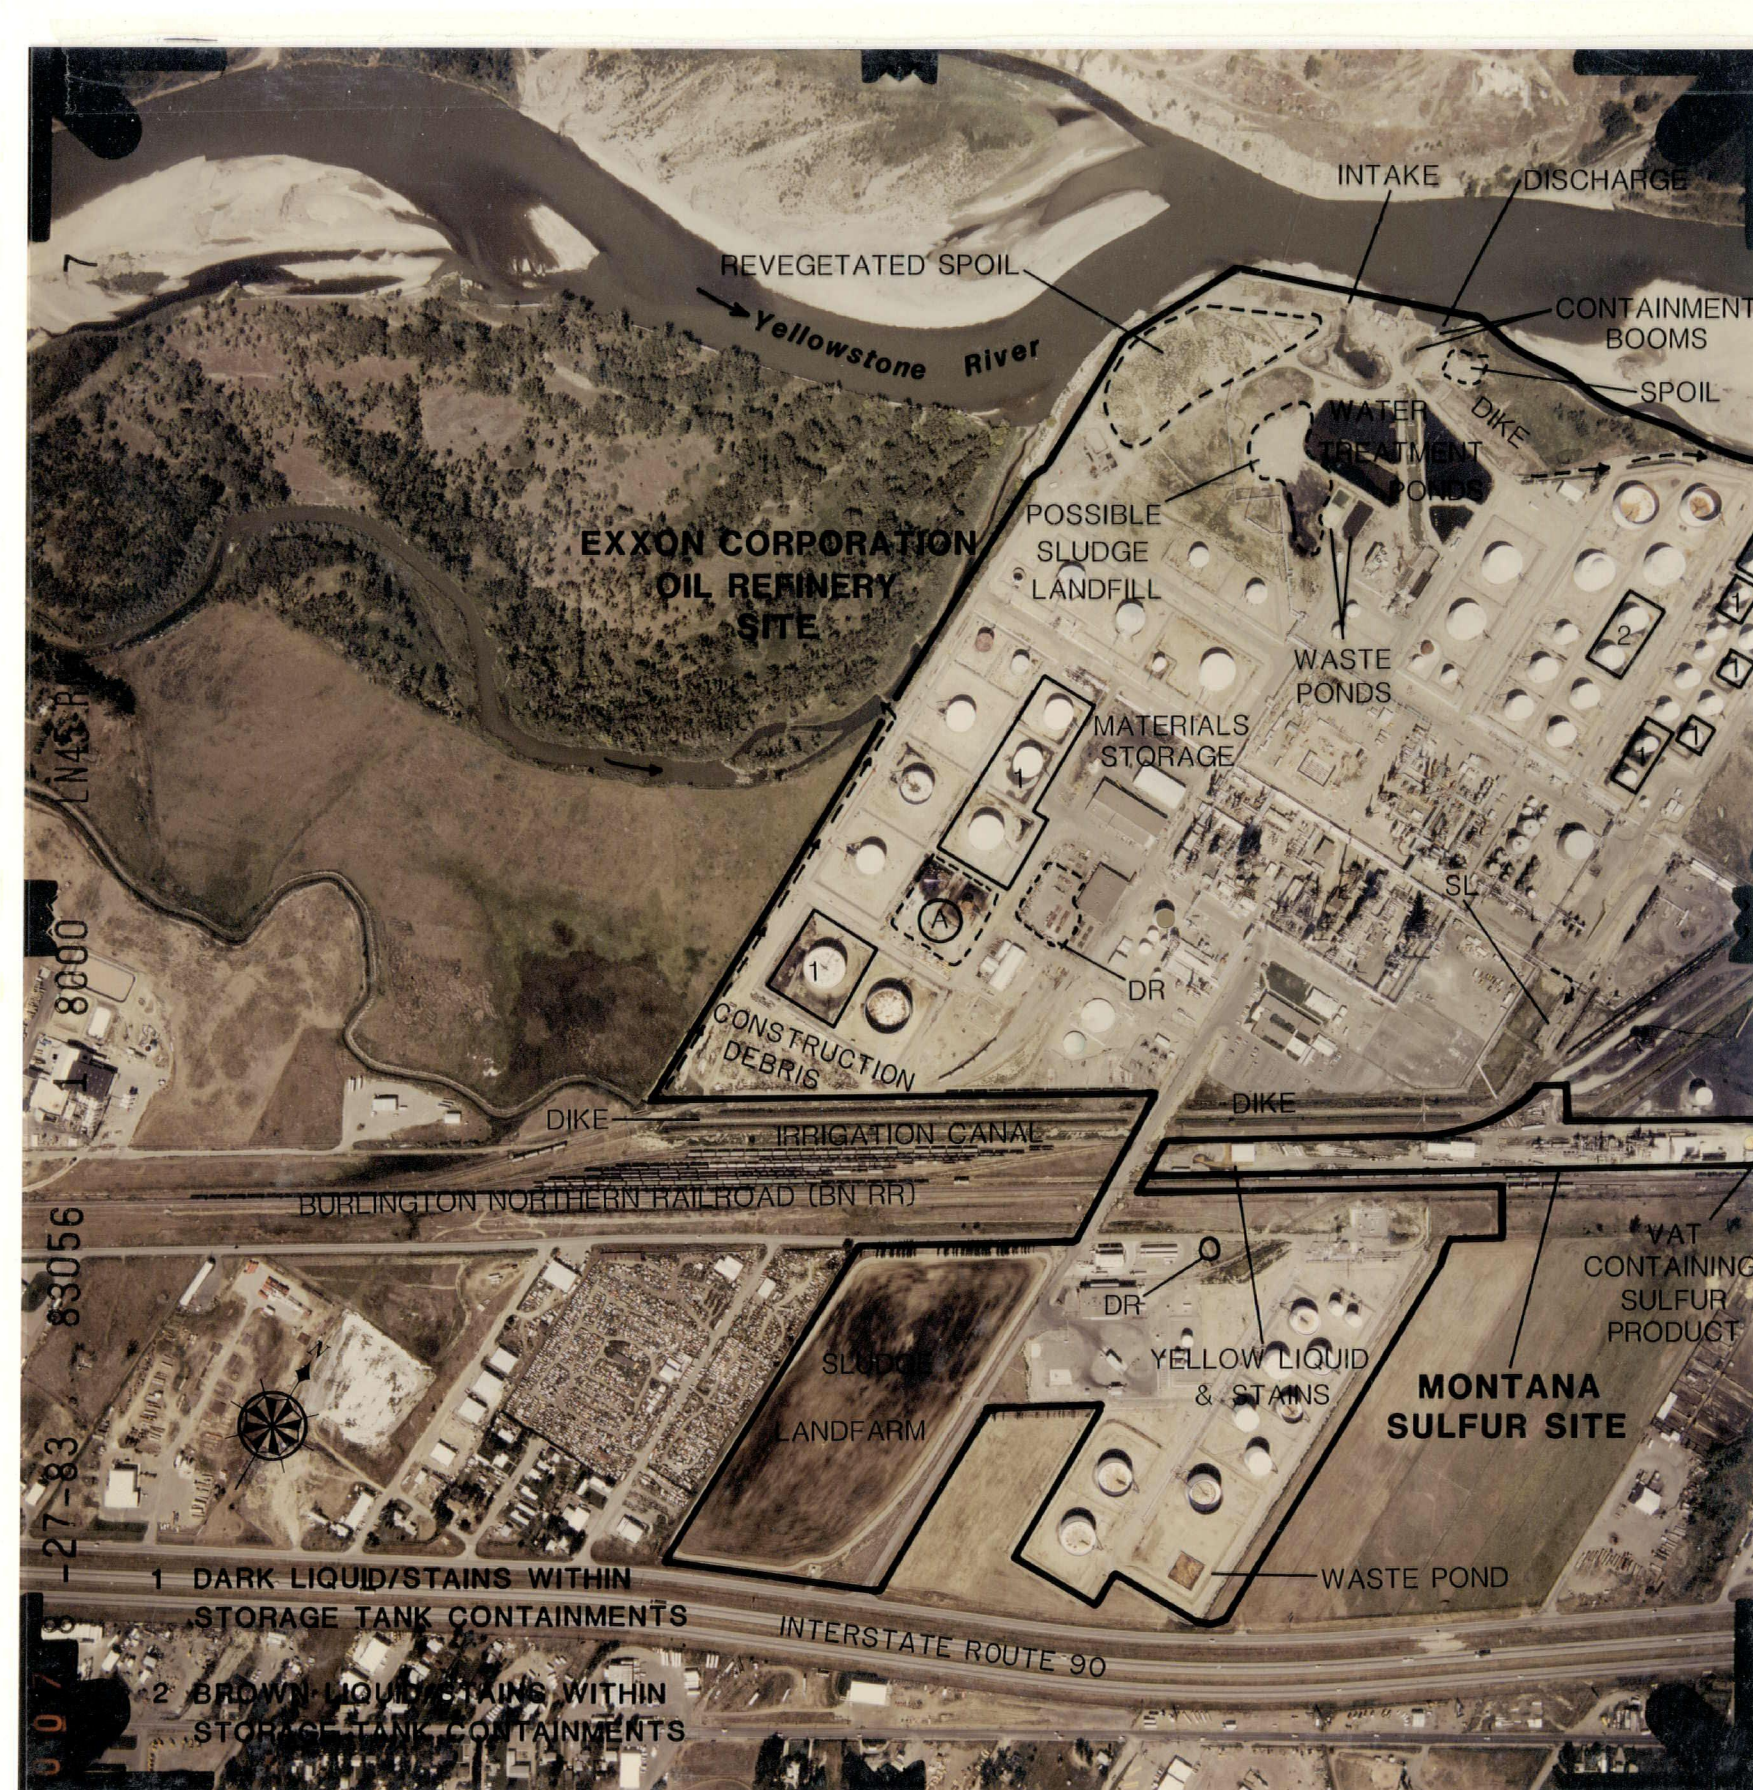
Figure 3. Exxon Corporation Oil Refinery and Montana Sulfur Sites, August 27, 1983, western halves. Approximate scale 1:8,000.

Northwest of the central processing complex (Figure 3) near the smaller complex of water treatment ponds, is an area that contains the intake and discharge points of the refinery's water treatment system. Two containment booms are in place on the discharge canal. Two spoil piles are present, one of which is revegetated. It appears as though oil sludge is being covered over with layers of earth. A large uncovered area of oil sludge is visible near the waste ponds.

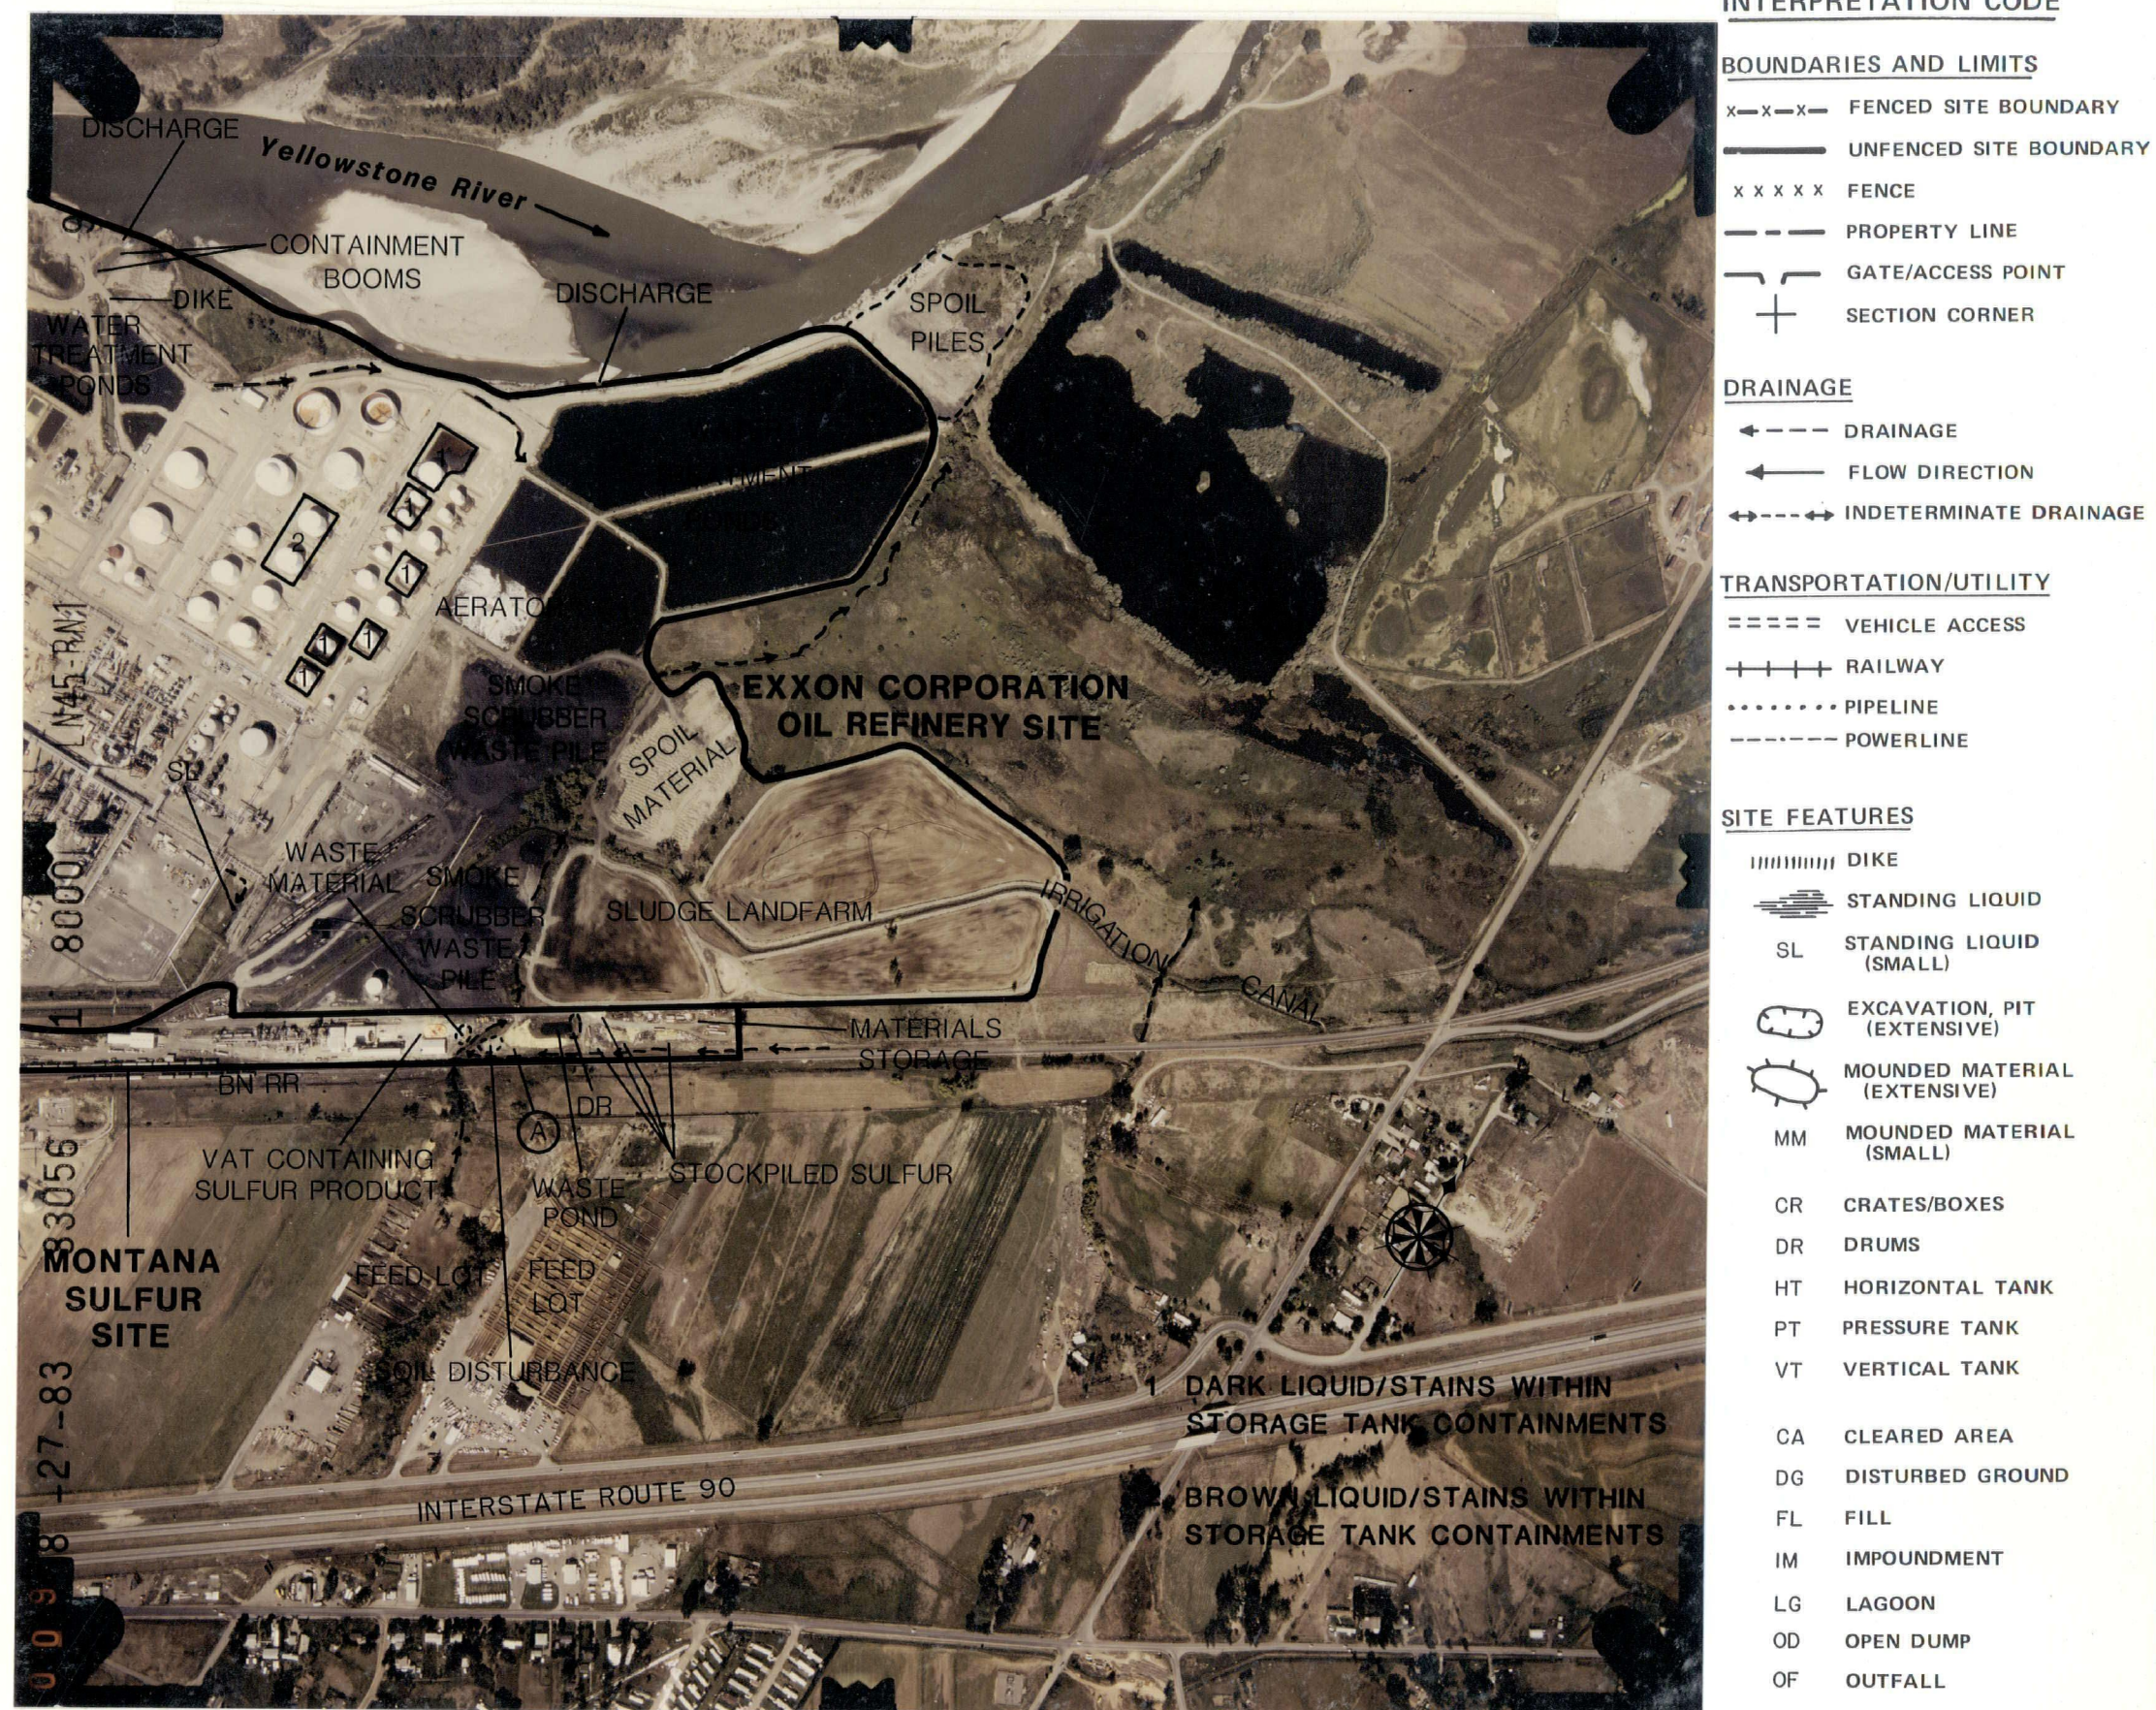
Figure 4. Exxon Corporation Oil Refinery and Montana Sulfur sites, August 27, 1983, eastern halves. Approximate scale 1:8,000.

A possible discharge point and standing liquid nearby are located on the east side of the central processing complex (Figure 4). East of the central processing complex are two large piles of smoke scrubber waste, a large area of earthen spoil accumulations, and three parcels of land used for sludge farming. A dry creek flows from a feedlot south of the railroad, through another site, Montana Sulfur, through the smoke scrubber waste piles, appears to cross an irrigation canal, and flows east into a wetland.

North of the above mentioned waste piles is another large complex of water treatment ponds. One discharge into the Yellowstone River is present in this area. Gray-and-white toned spoil piles are seen near the water treatment ponds. No changes are evident in this area.

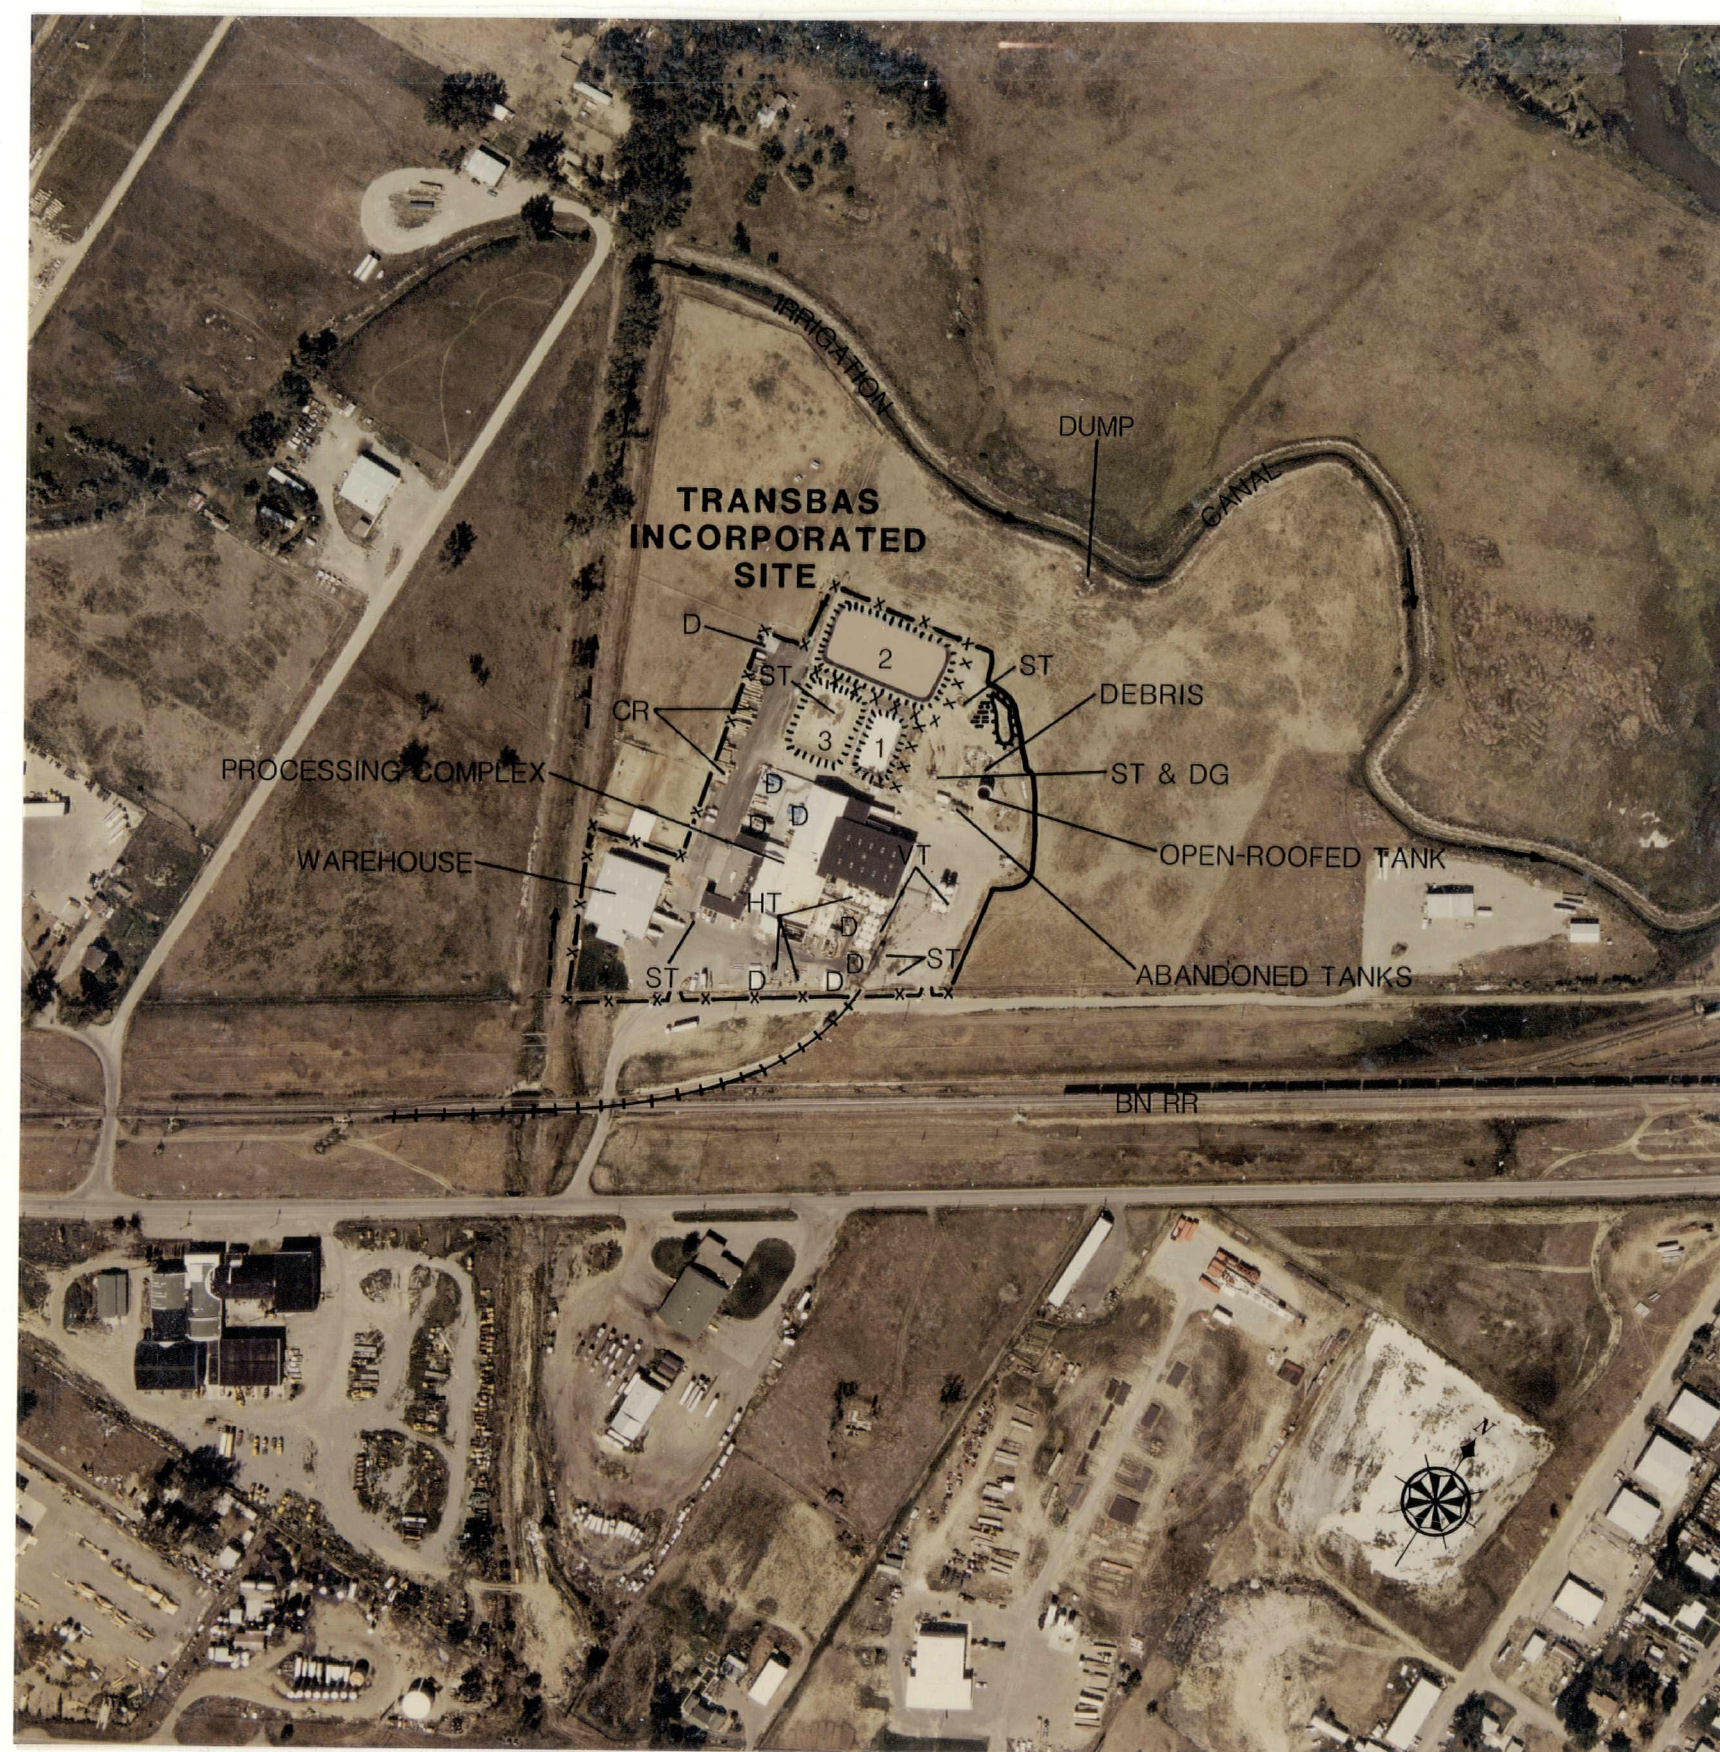
Figure 5. Transbas Incorporated site, August 27, 1983. Approximate scale 1:3,840.

Waste Ponds 1 and 2 are unchanged. Waste Pond 3 now contains no liquid and it appears as though the lining has also been removed. Some dark stains are present within the pond.

Stains and soil disturbances are present to the east of ponds 1 and 2. In the earlier report, this area had stains and a small pit containing orange liquid.

Drums are located in two areas adjacent to the central processing complex structure. A third drum storage area is located west of the three waste ponds.

Some dark stains are observed on the concrete apron at the southeast corner of the property.

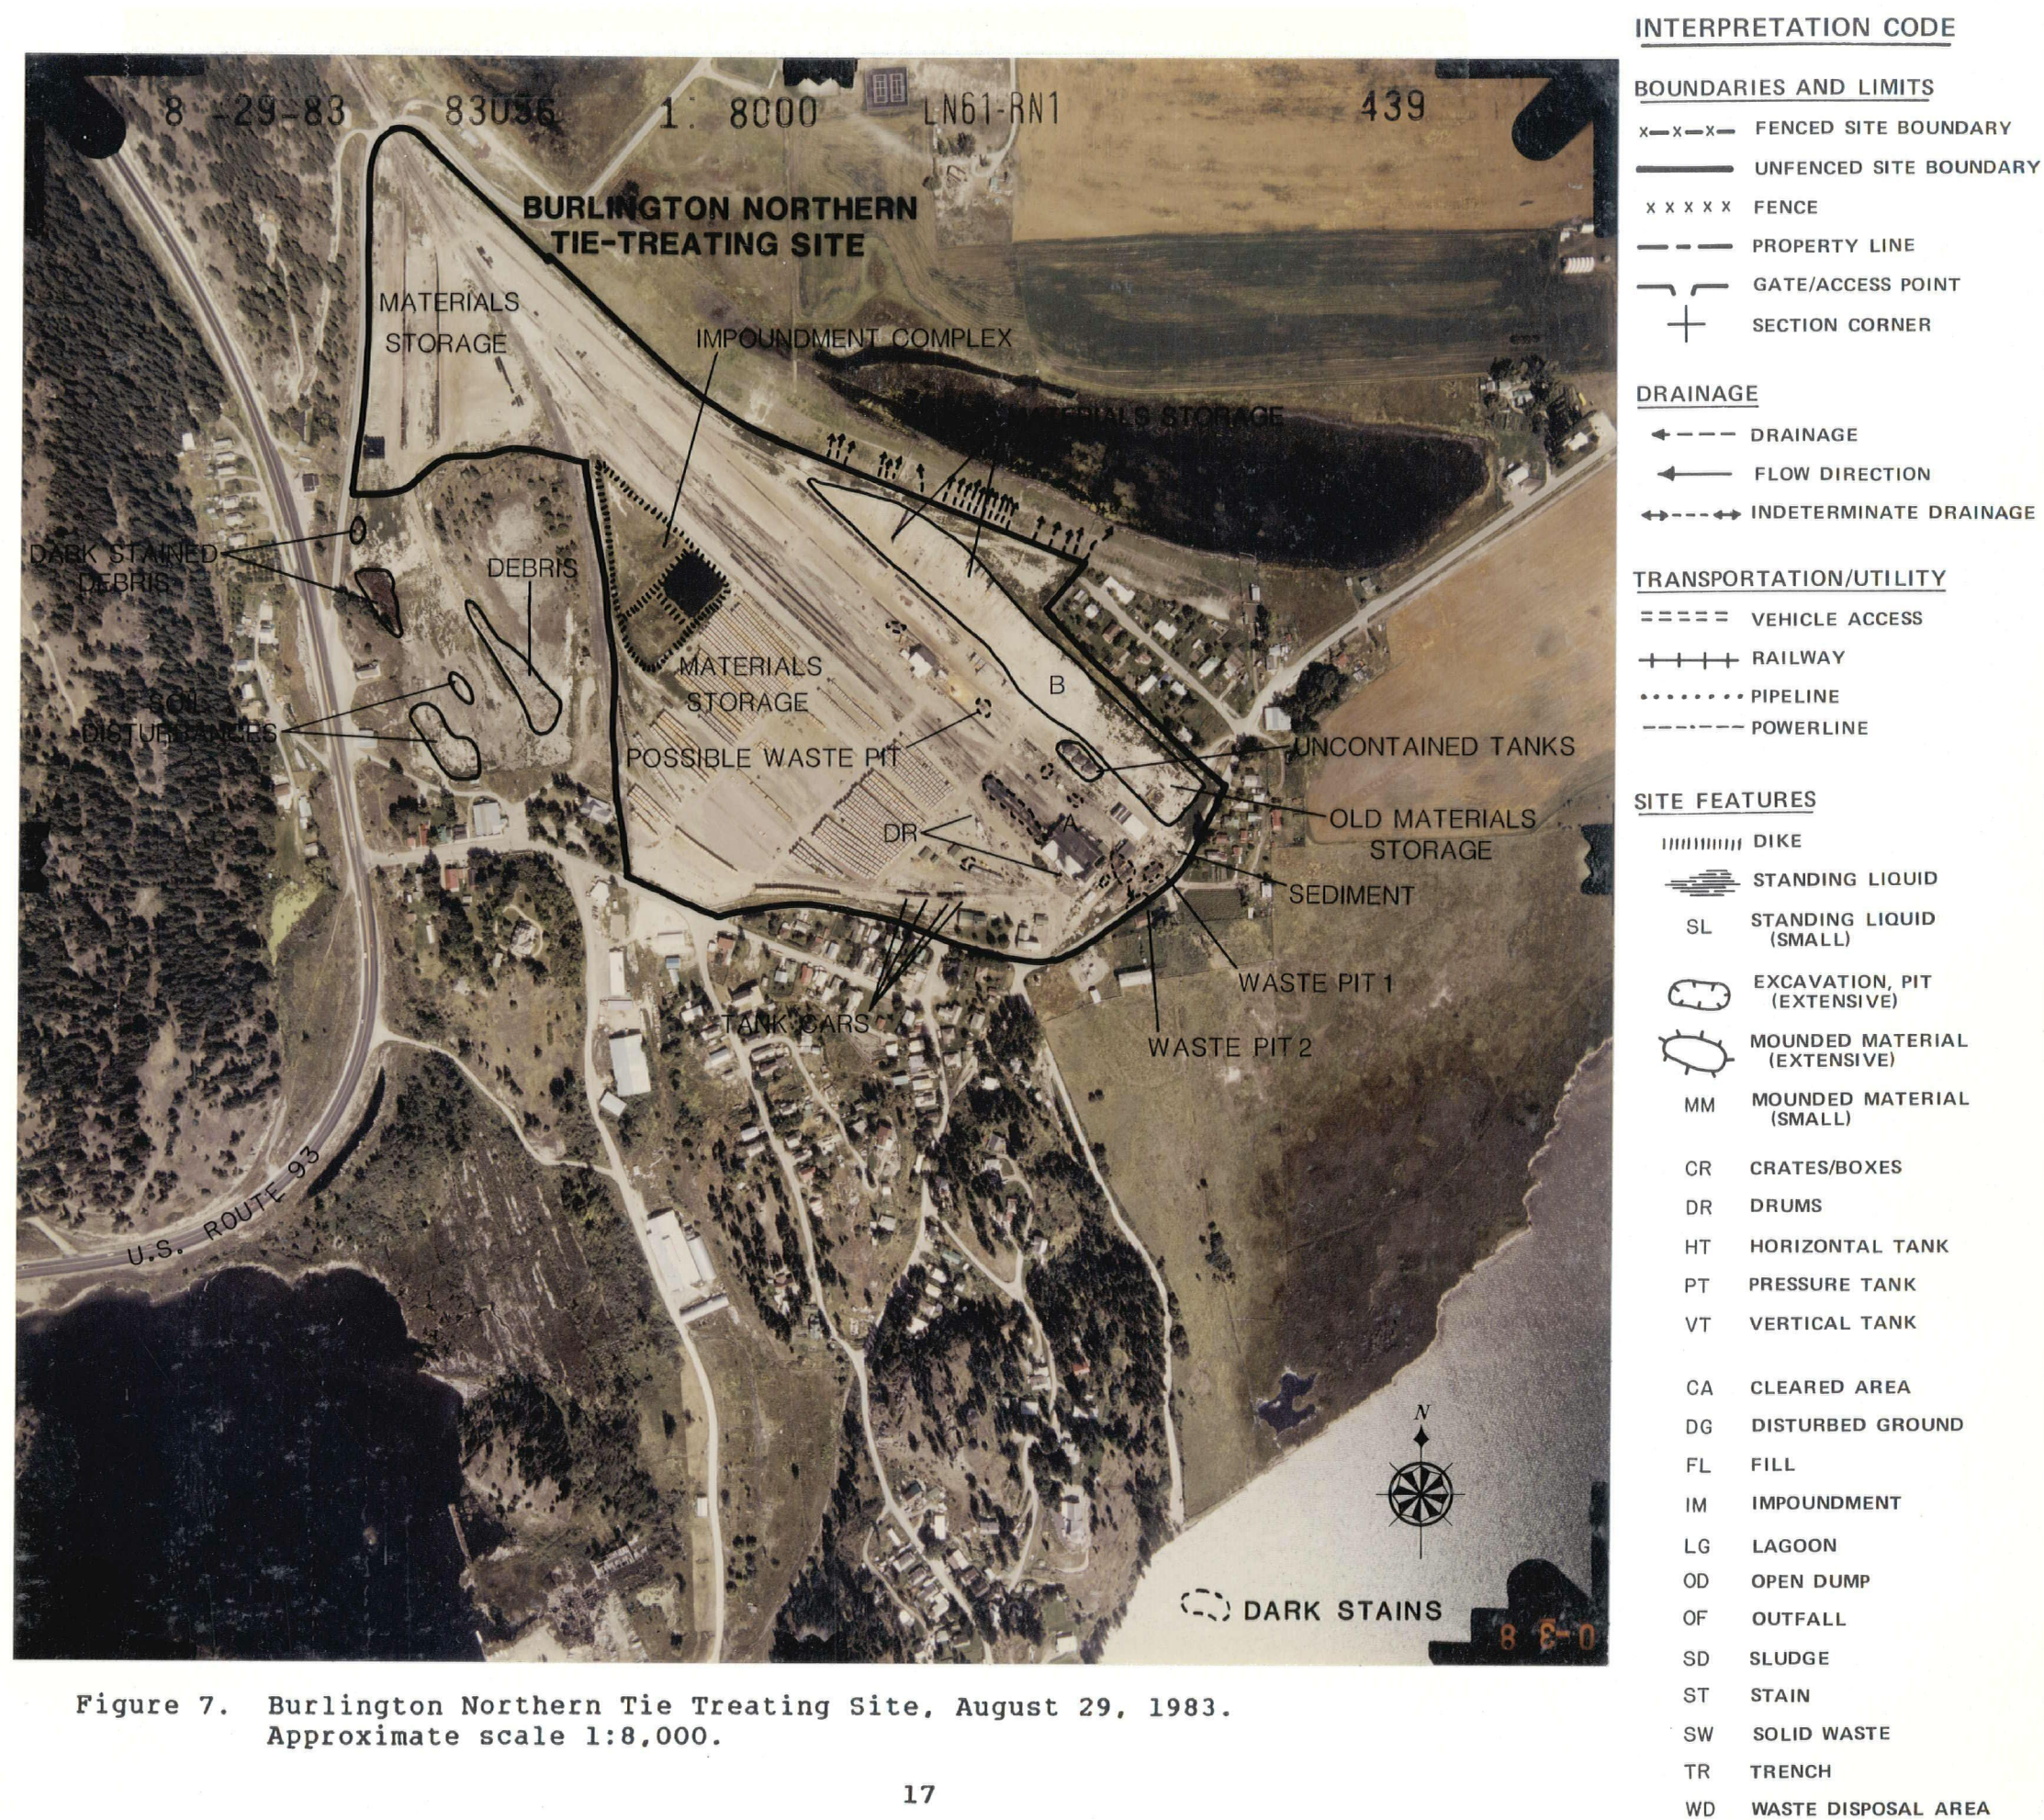
Figure 7. Burlington Northern Tie Treating Site, August 29, 1983.
Approximate scale 1:8,000.

The main processing area is located at annotation "A". Dark stains are at various locations near the processing area. Runoff from this area flows to the southeast into waste pit number 1 where it is contained. Waste pit 2 is seen immediately to the south. No apparent drainageway from the processing area can be seen, but the pit is darkly stained. A small area of sediment is located north of waste pit 2. This sediment may have resulted from past runoff from the processing area. Three uncontained tanks are visible north of the processing area; however no stains are associated with them and any spills would remain in the immediate vicinity. Area "B" is a materials storage area. The southeastern end is no longer in use and is becoming revegetated. The northwestern end is still in use. Some rill erosion is evident north of the facility; however it is probably related to extensive overgrazing in these areas.

An impoundment complex is located in the western portion of the facility. It consists of three impoundments, one of which is filled with liquid. The two unused impoundments are completely revegetated. No evidence of vegetation damage was observed.

Another materials storage area is present in the northwestern portion of the facility and south of that are three accumulations of debris, two of which have dark stains. Two areas of soil disturbance are visible nearby.

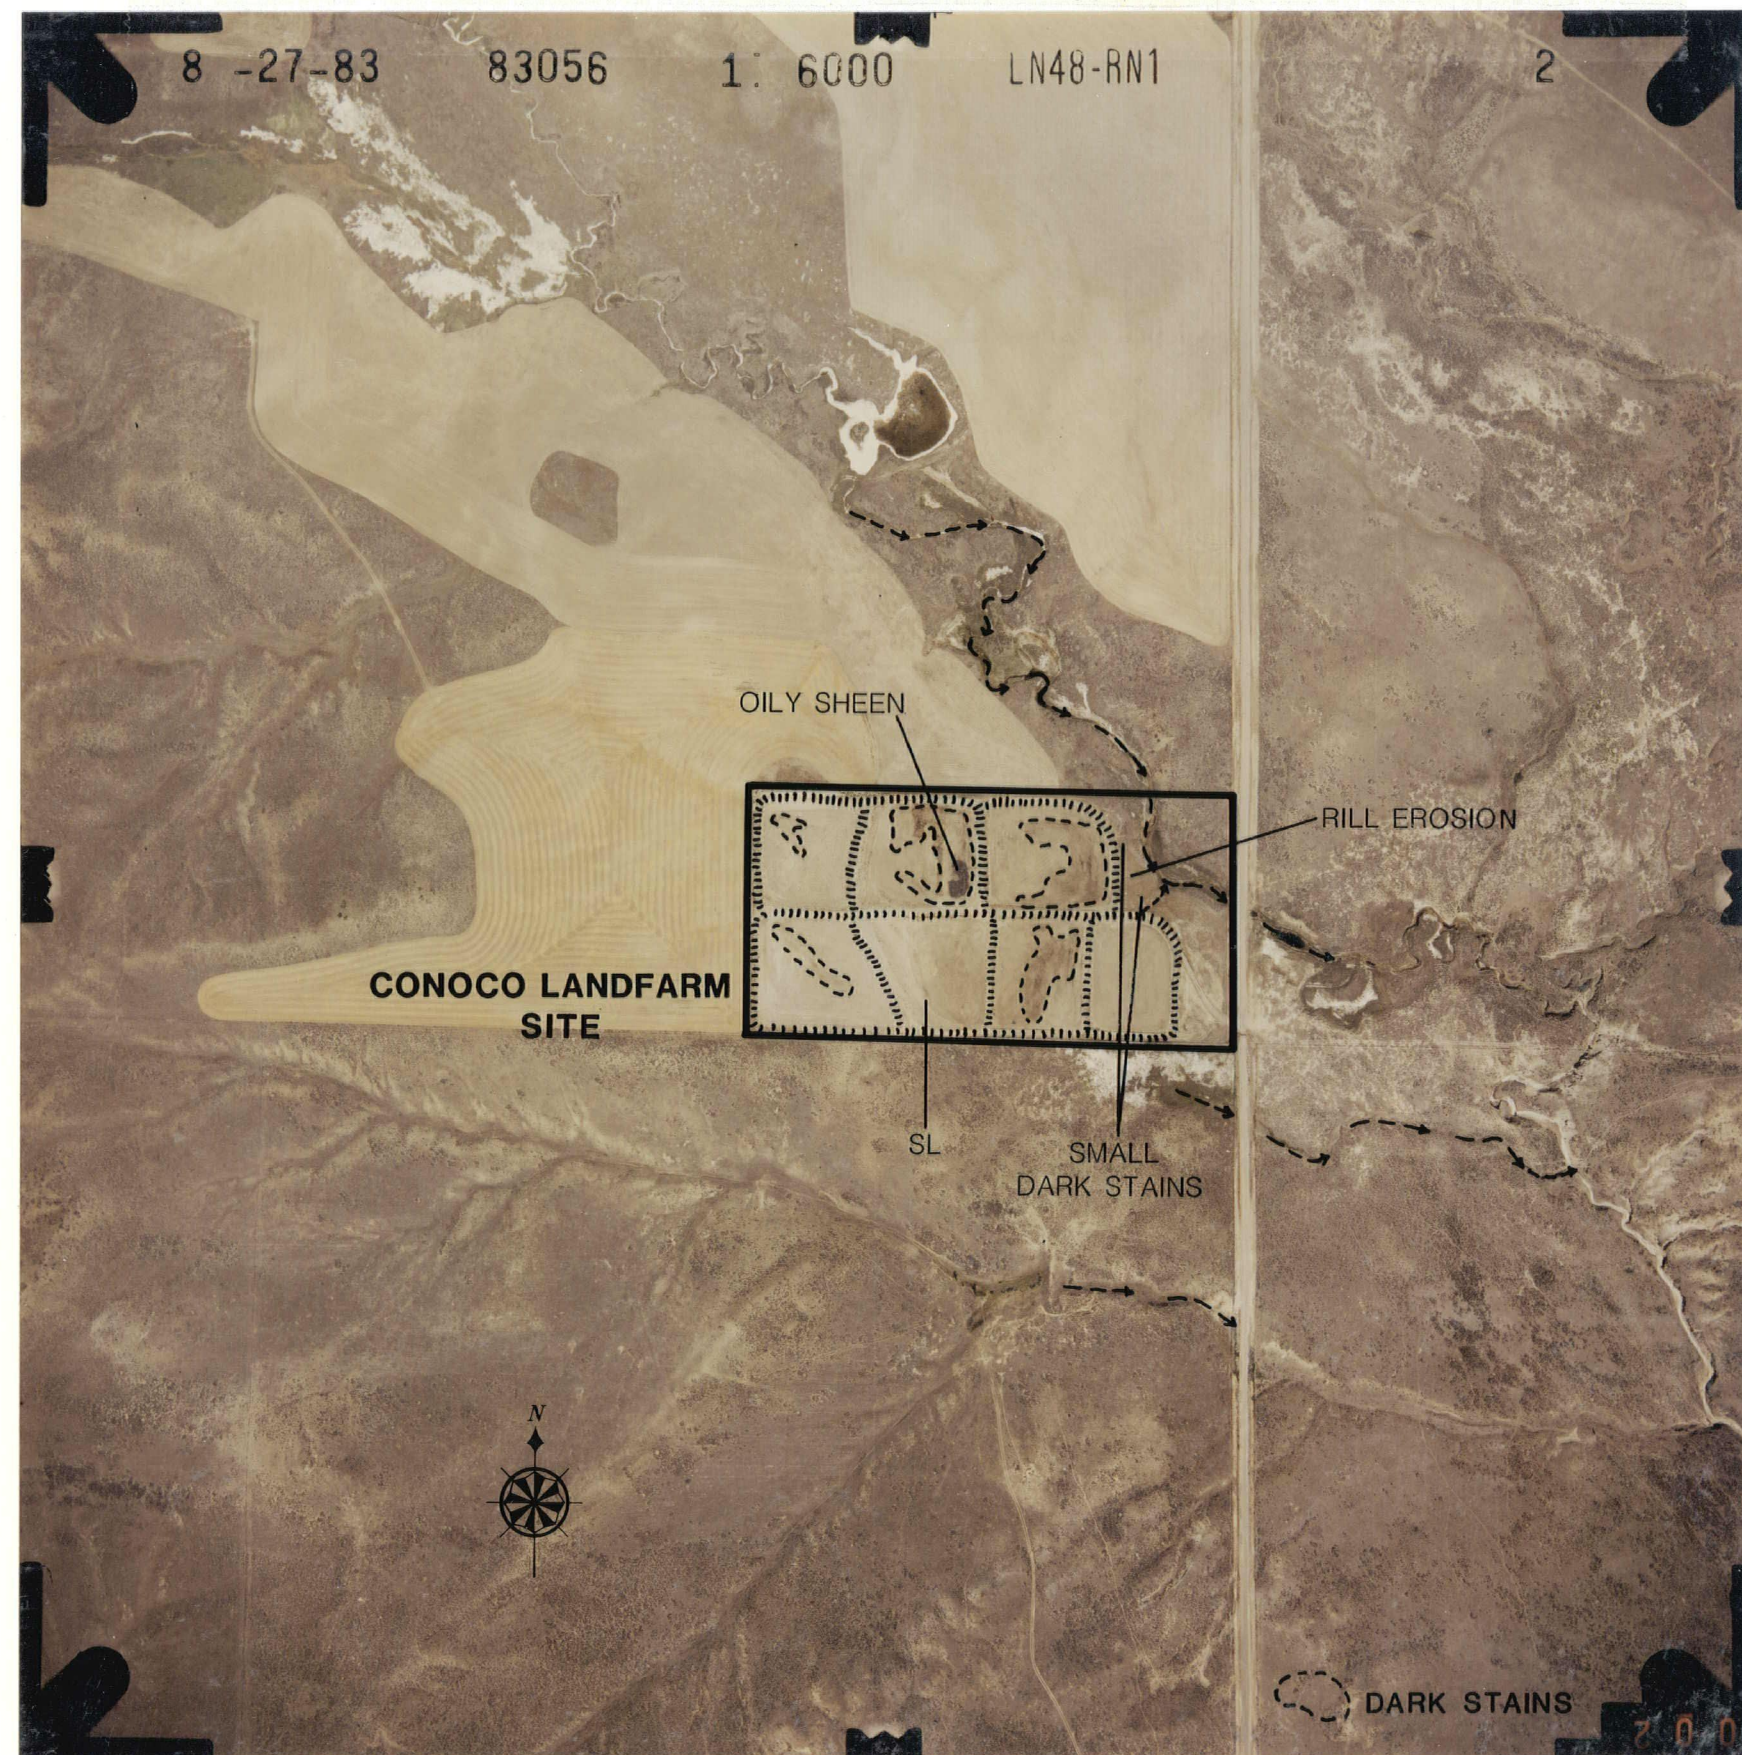
Figure 9. Conoco Landfarm site, August 27, 1983. Approximate scale 1:6,000.

The Conoco Landfarm Site (Figures 8 and 9) is located approximately 16 kilometers (10 miles) north of Billings, Montana. Surface drainage flows to the southeast. The site consists of seven small landfarm areas separated by a berm network. The areal extent of the total site is approximately 10.5 hectares (26 acres). Apparently, each of the small areas or "cells" is used for the spreading of sludge by-products. Five of the seven cells have dark stains within them. One cell had some sludge with its oily sheen visible on the surface. No breaches or seepage points were detected on the site's embankments. One small area of rill erosion was observed near an embankment. Two small dark stains are visible nearby.

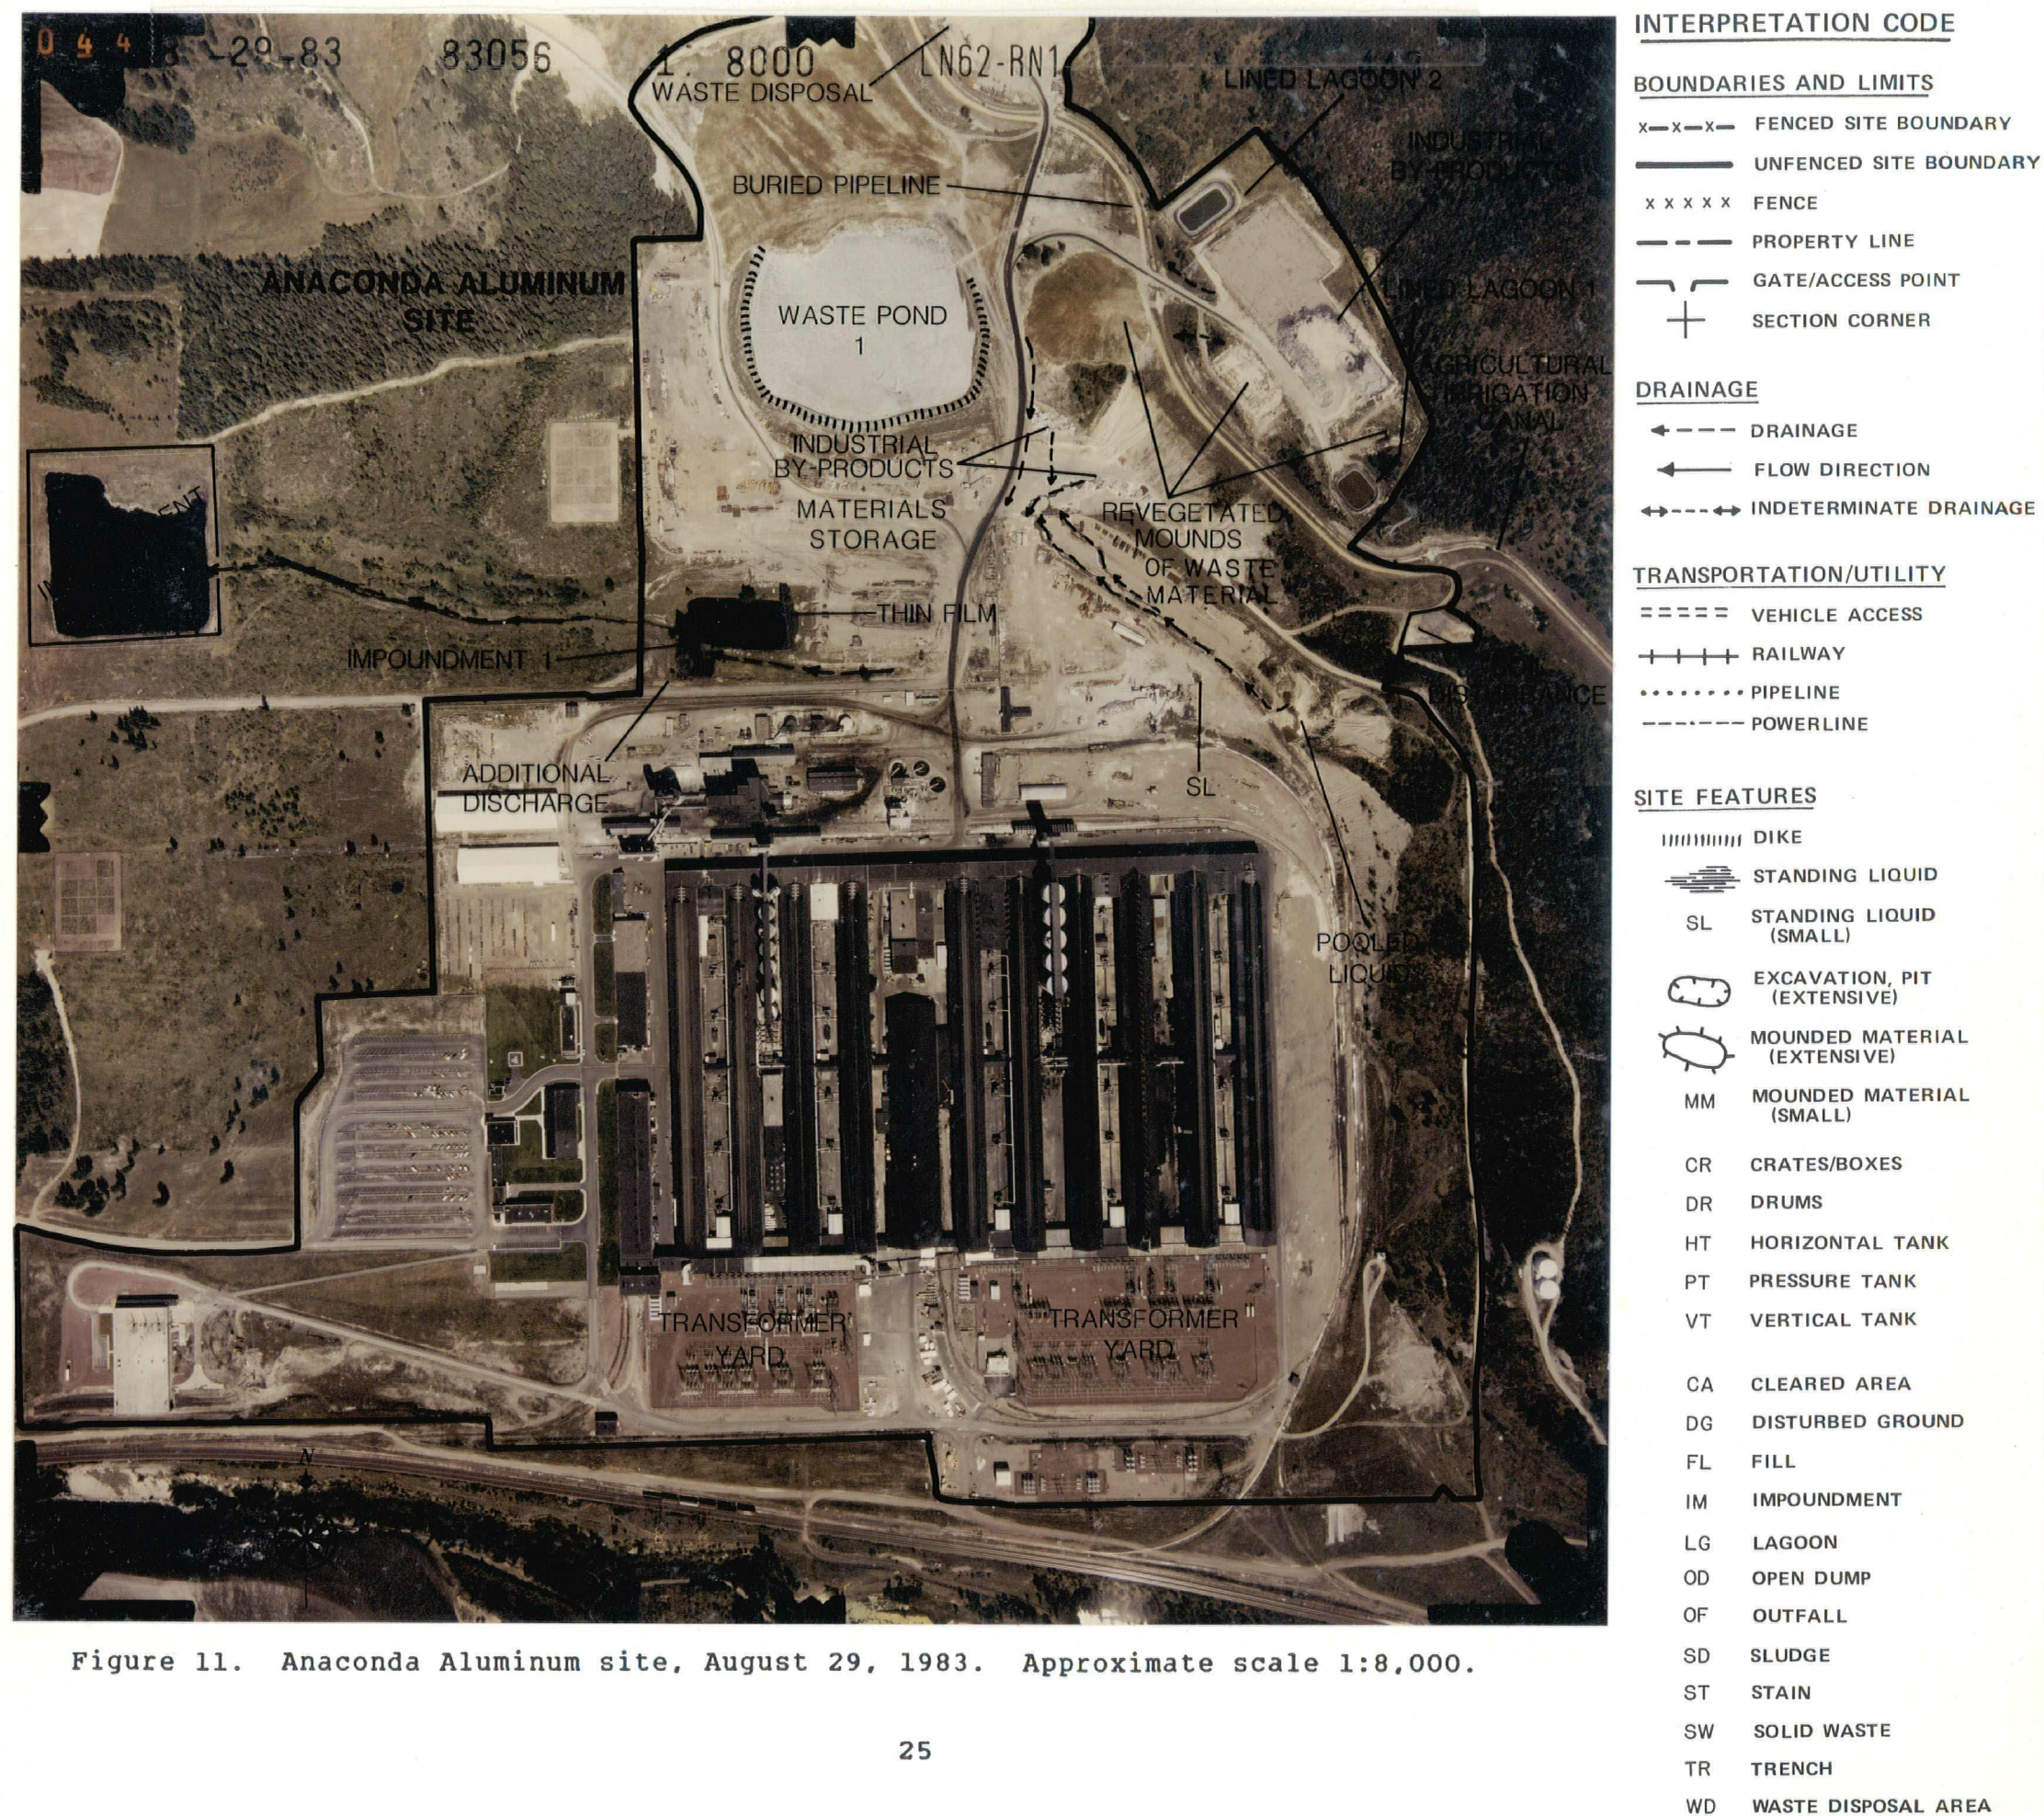
Figure 11. Anaconda Aluminum site, August 29, 1983. Approximate scale 1:8,000.

North of the northeast corner of the main processing building is an area of pooled liquid. A drainage pathway proceeds to the northwest from that point. Evidently, the flow collects in a level area adjacent to a fence. To the east and north of this collection area are two accumulations of apparent industrial by-products. Liquid from one of these accumulations flows to the same above mentioned collection area. A large waste pond (Waste Pond 1) filled with grayish material can be seen nearby. The berm around this pond is secure with no leakage or seepage points detected.

East of Waste Pond 1 is an area containing two lined lagoons and three apparent mounds of waste. An underground pipeline leads from lined lagoon 2 to Waste Pond 1. A large accumulation of industrial by-products are present between the two lagoons. The by-products have a gray tone and are situated in a fenced area apparently dedicated to disposal of such waste. An access road can be seen leading up to this area. The other two waste accumulations are in the process of being revegetated. Another revegetated mound of apparent waste material is present immediately to the west of Lagoon 2. Northwest of Lagoon 2 is one more waste disposal location. Grayish debris and material have been deposited in a shallow pit. No runoff would be transported to adjacent areas. Some surface runoff from this area might reach the agricultural irrigation canal to the west.
